LEXINGTON PRESERVATION HANDBOOK

**Guidelines For Historic Preservation And New Construction
In The Lexington, Georgia Historic District**

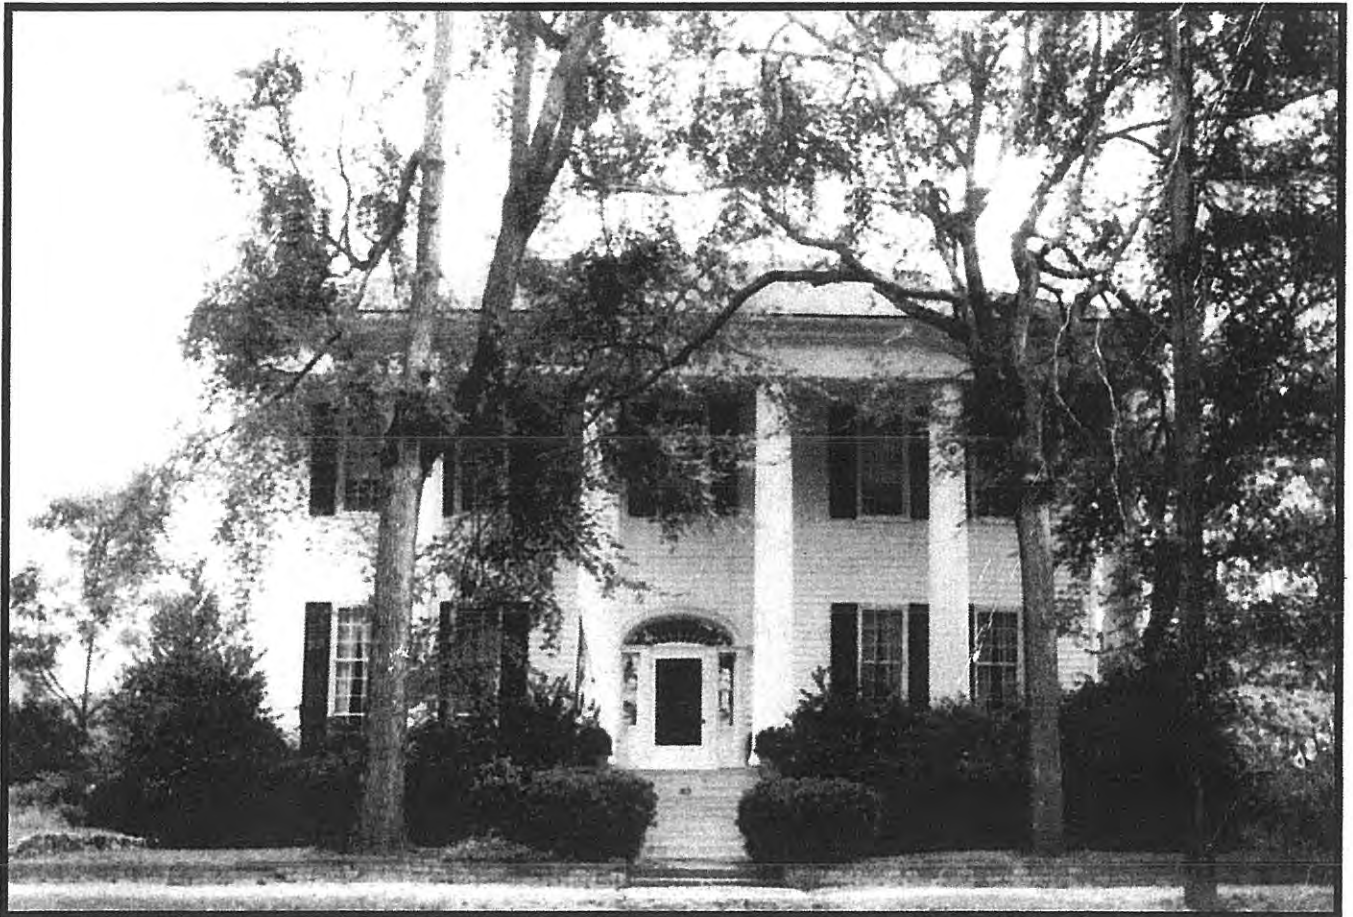
*Compiled By Beverly K. Montgomery
For The City Of Lexington And
The Lexington Historic Preservation Commission
Lexington, Georgia - 1991
rev. 2005*

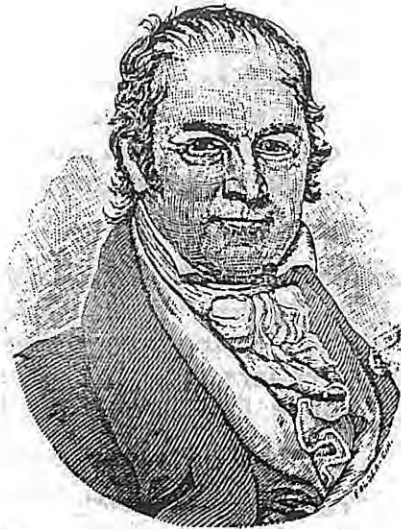
This publication is also designed as a reference for citizens who may be contemplating alterations to historic buildings or new construction within the district. Applicants are encouraged to consult with the Lexington Historic Preservation Commission during the planning stages of a project, before applying for a Certificate of Appropriateness, in order that any questions or problems that arise may be addressed.

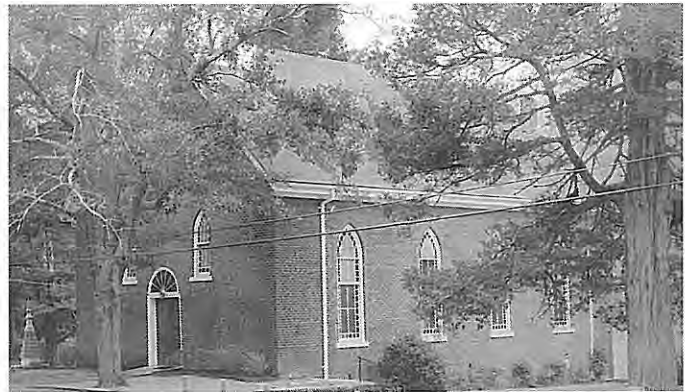
*Left: The Lexington Presbyterian Church, (building ca. 1893) houses one of the oldest Presbyterian congregations in Georgia.
Above: The Lexington Baptist Church, ca. 1851.*

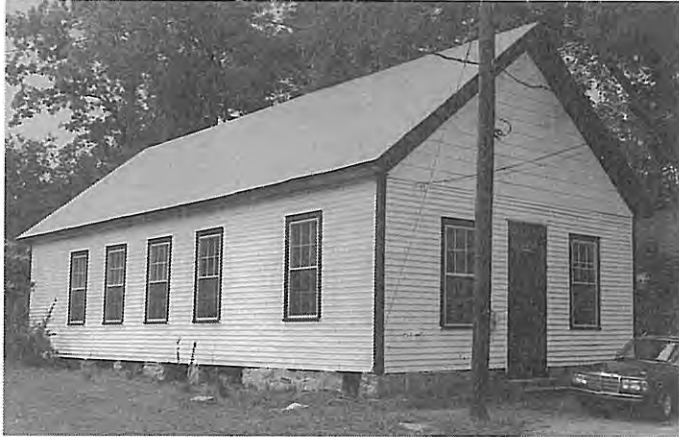
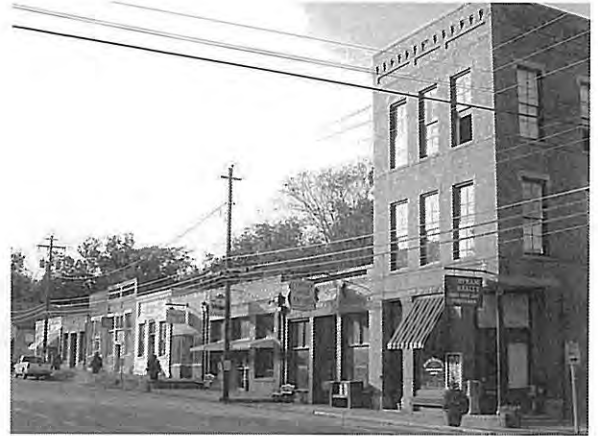
*Left: The original office of the Oglethorpe Echo located on North Gilmer Street.
Right: Downtown Lexington.*

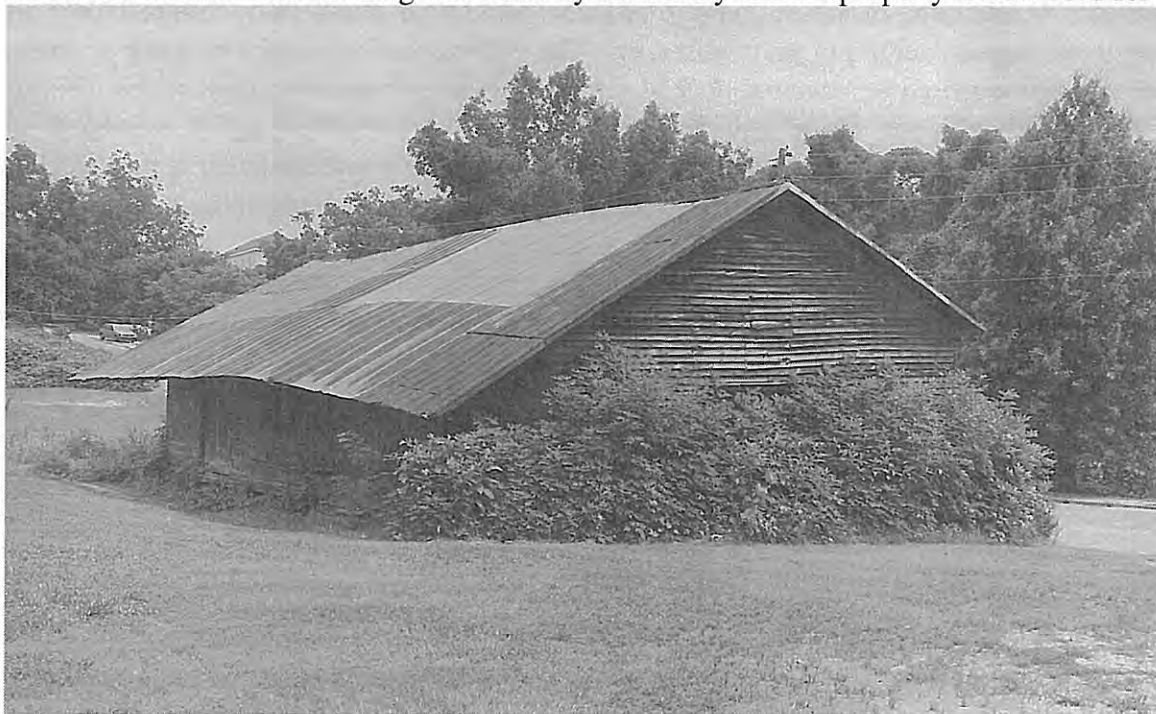
Cotton Seed Warehouse on East Boggs Street.

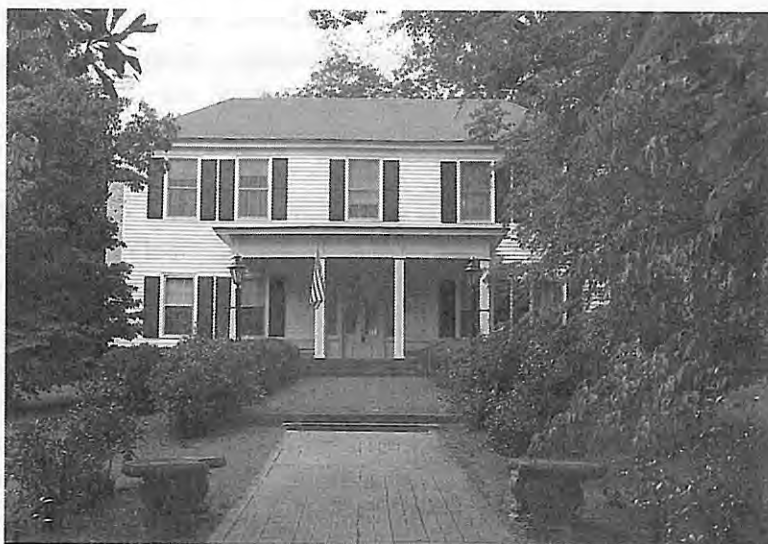
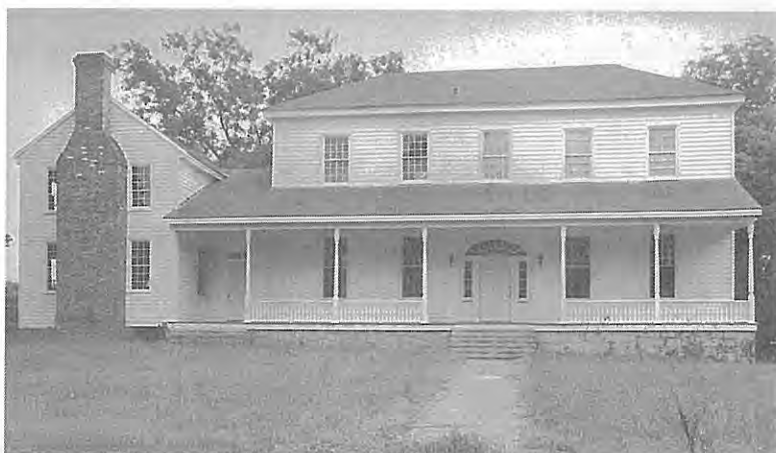
*Left:
The Lumpkin-Maxwell-Montgomery House, ca.
1790's-1827.*

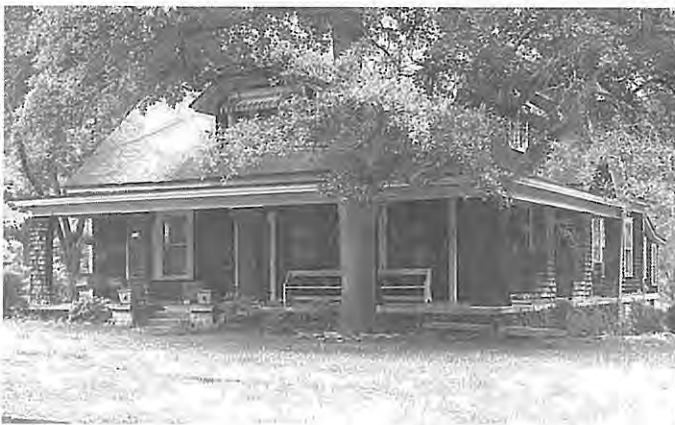
The Mathews House, early 20th Century

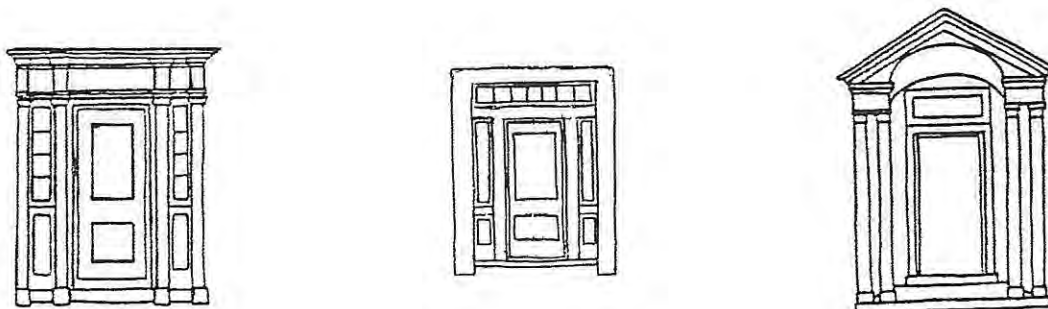
While Colonial Revival doors and surrounds were generally supposed to be patterned after the originals; with only a few exceptions, buildings in this style tended to be somewhat eclectic in their use of details from the earlier classical periods, and still popular elements of the Queen Anne style, such as the single large pane of glass in the door, frequently found their way into the design as well. Examples can be seen on the Epps House on Main Street, and on the Maxwell-Johnson House on Meson Street.

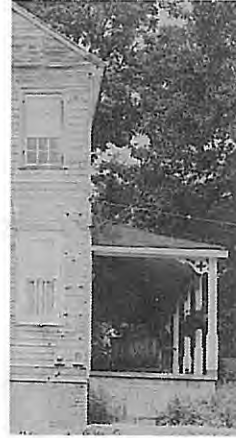
Classical Entrance Portico

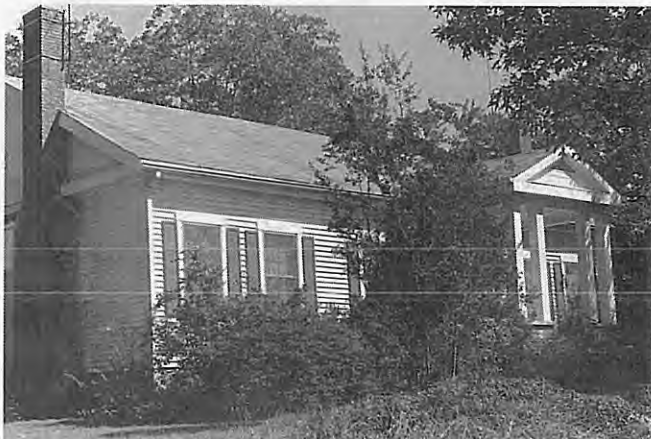
*The Dupree-Applying House, ca. 1800.
The portico is part of an 1830s addition.*

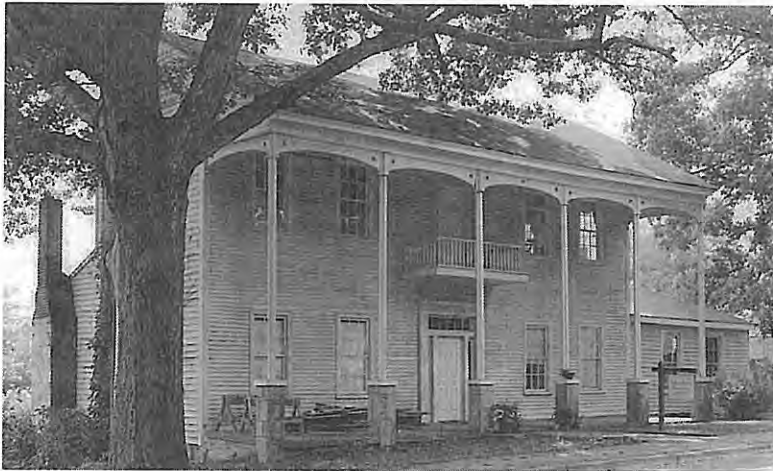
The Knox House-American Legion Building, ca. 1857.

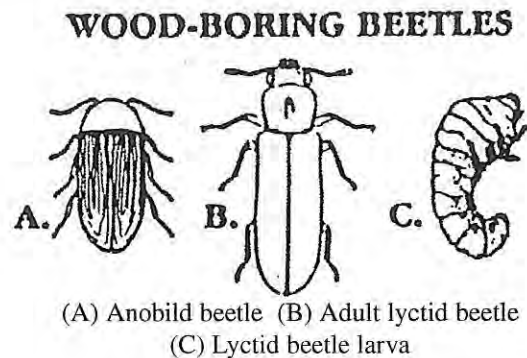
If powder post beetles or old house borers are discovered in isolated areas of a building, wood preservatives (such as chromated copper or zinc naphthanate, both anti-fungicides as well) or other similar preservative treatments can be applied. If, however, the infestation is extensive, tenting and fumigation of the structure may be required.

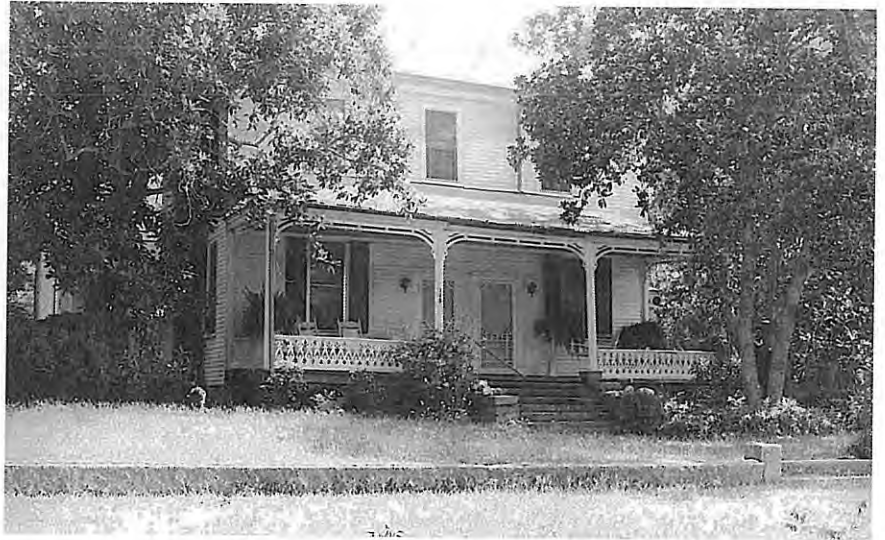
A straight or elegantly curving walkway leading to the front entrance, was placed and enhanced with plantings to give maximum effect to the house. A less elegant drive led to the work/service areas and buildings which were carefully located behind the house and screened from view with strategically placed plants. Concrete walks and drives began to be seen near the very end of this period. Though natural concrete had been available for decades, it was a less than satisfactory building and surfacing material. It was not until the development and production of portland cement based concrete during the late 19th century, that concrete began to see more widespread use.

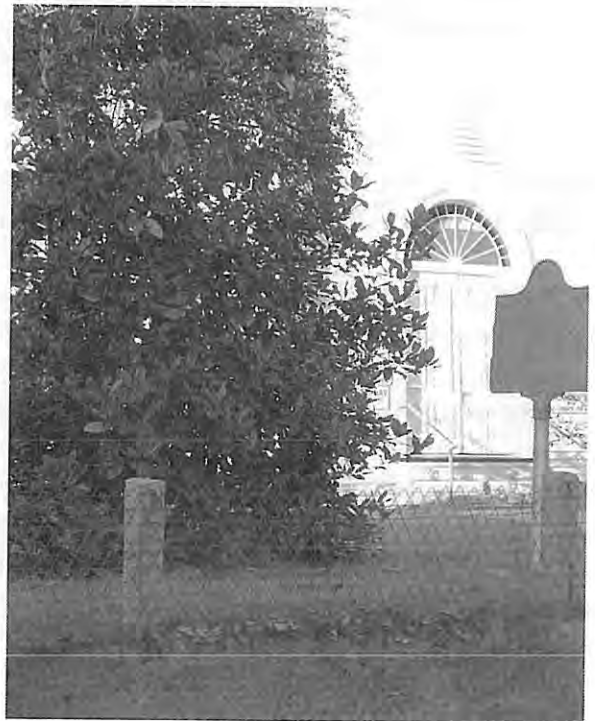
centerpiece of a decorative bed or arrangement of beds.

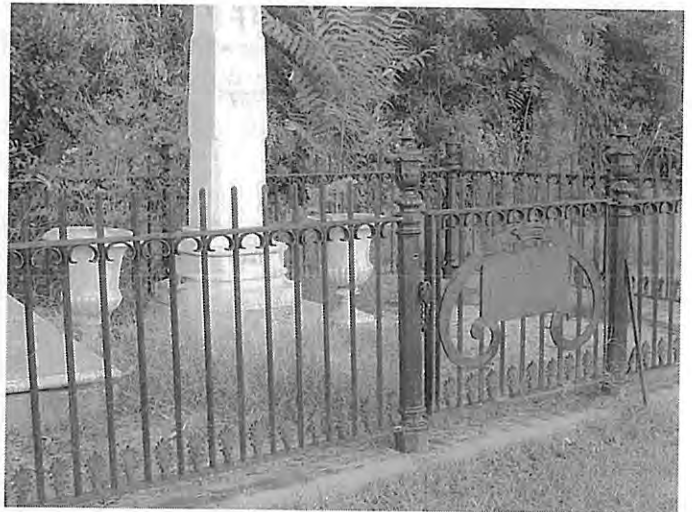
A relatively unusual fence type very popular in Lexington in the late 19th century consists of slightly tapered granite posts which supported wire mesh fencing (not to be confused with modern chainlink). This fencing was used primarily along the sides and rear of properties, although cemetery and churchyard of the Lexington Presbyterian Church are enclosed by this type fencing. Many of these old posts remain throughout the town.

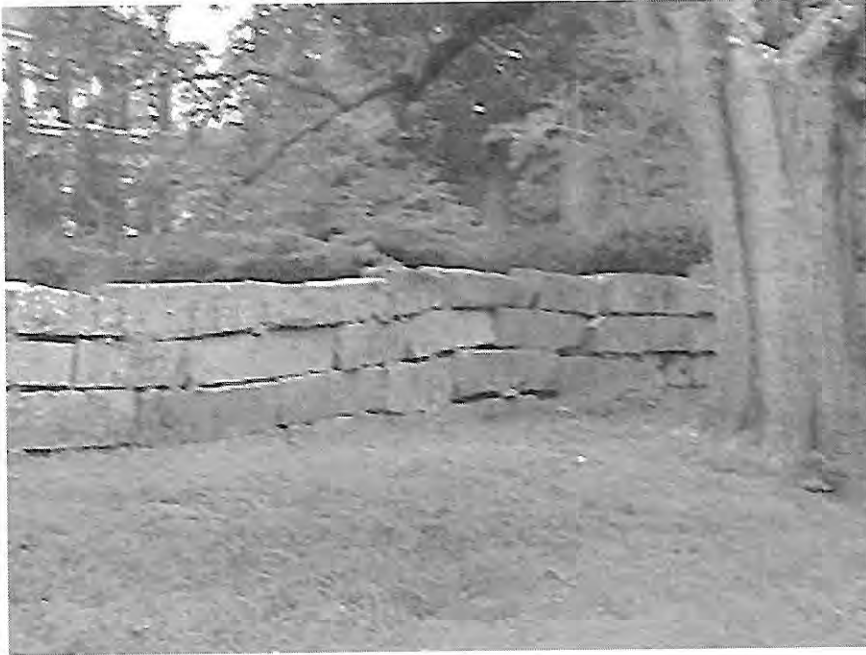
Stacked, semi-dressed granite wall

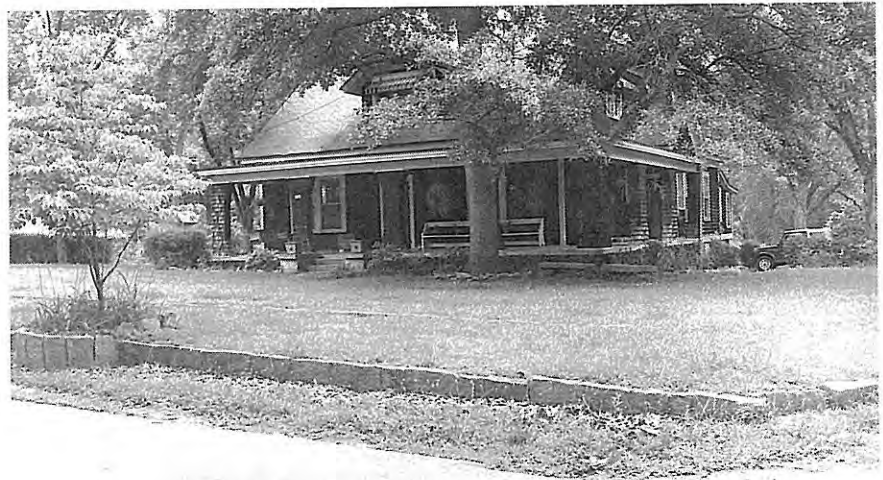
With the rise of the Downing style of naturalistic landscaping, in which properties merged visually into each other creating a natural, parklike setting, the use of walls and fences, particularly in the front of a property, declined.

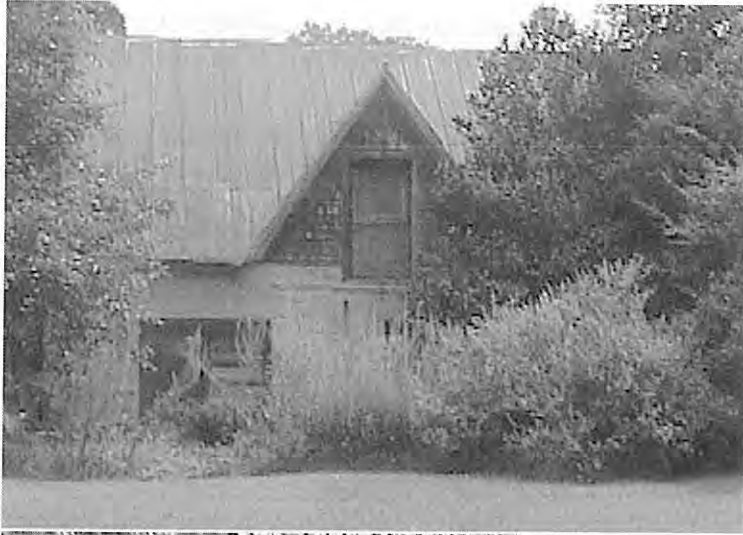
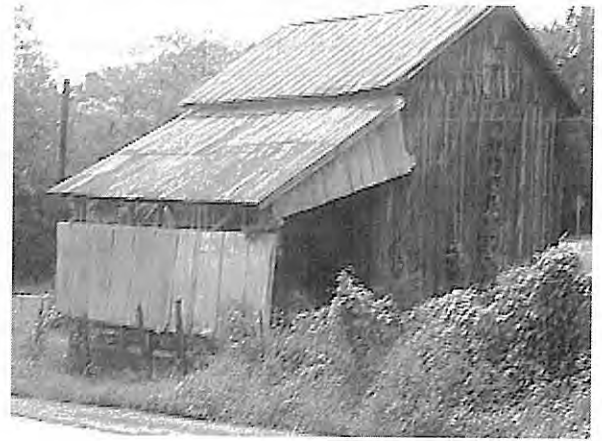
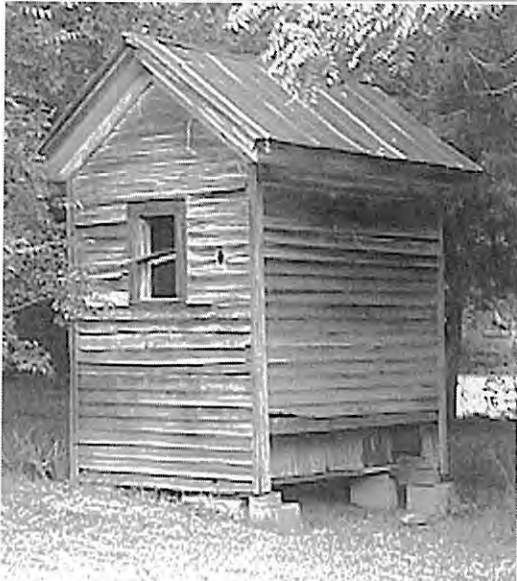
Above Left: Howard-Cunningham granite barn
Above Right: Crawford Barn
Left: Howard-Cunningham Privy.

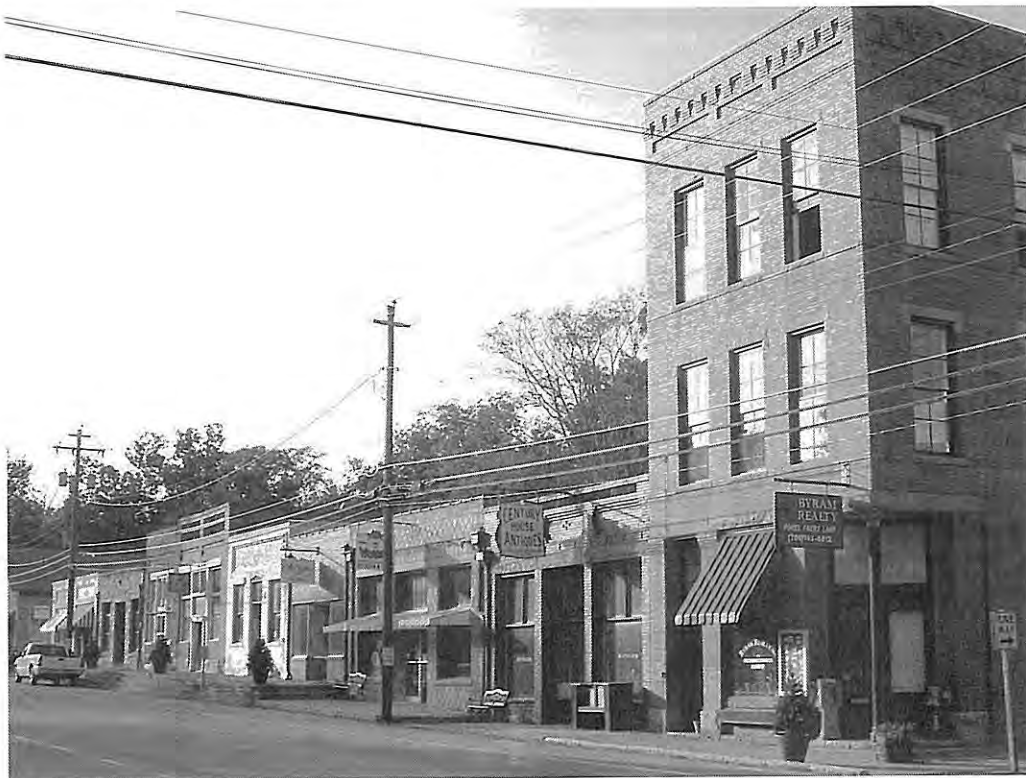
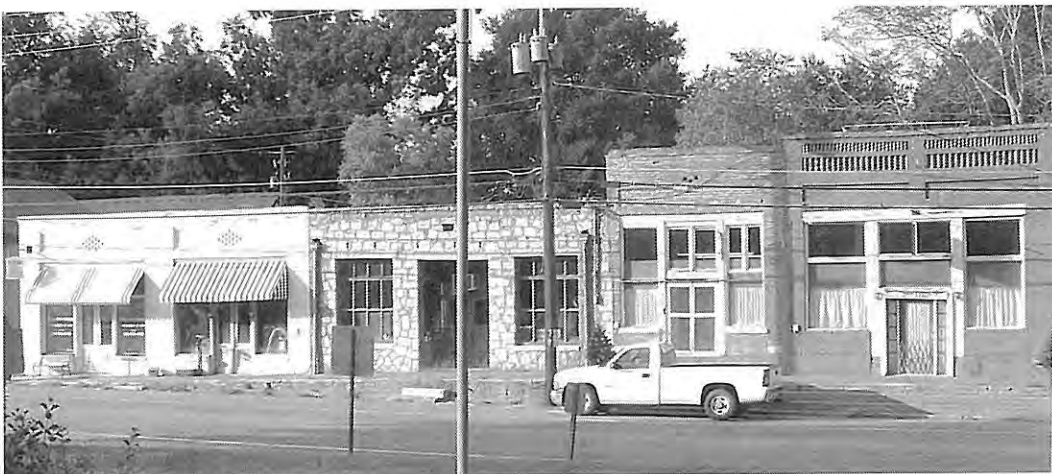
The downtown commercial district also suffers from an excess of pavement and a lack of street trees or other plants. The maze of overhead utility lines and poles, detract from the appearance of the area and make the addition of street trees difficult.

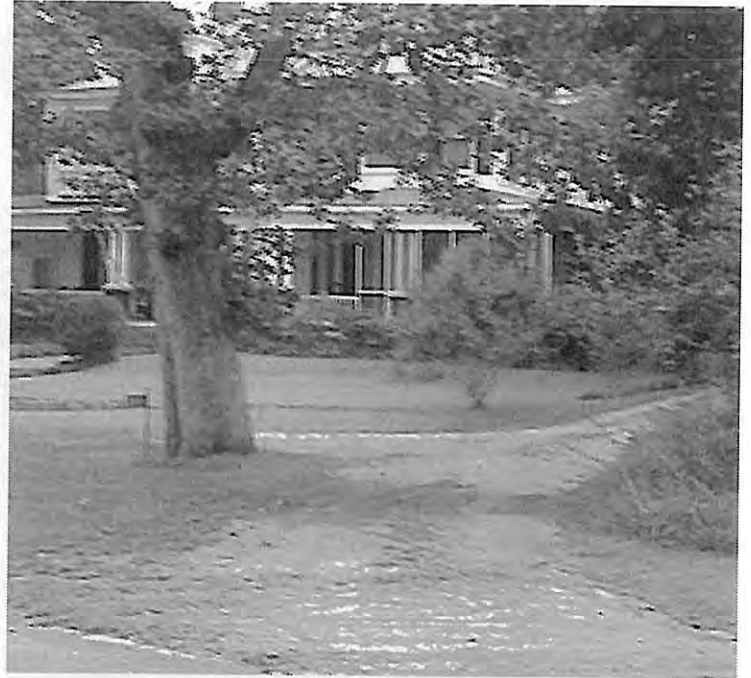
Traditional dirt drive.

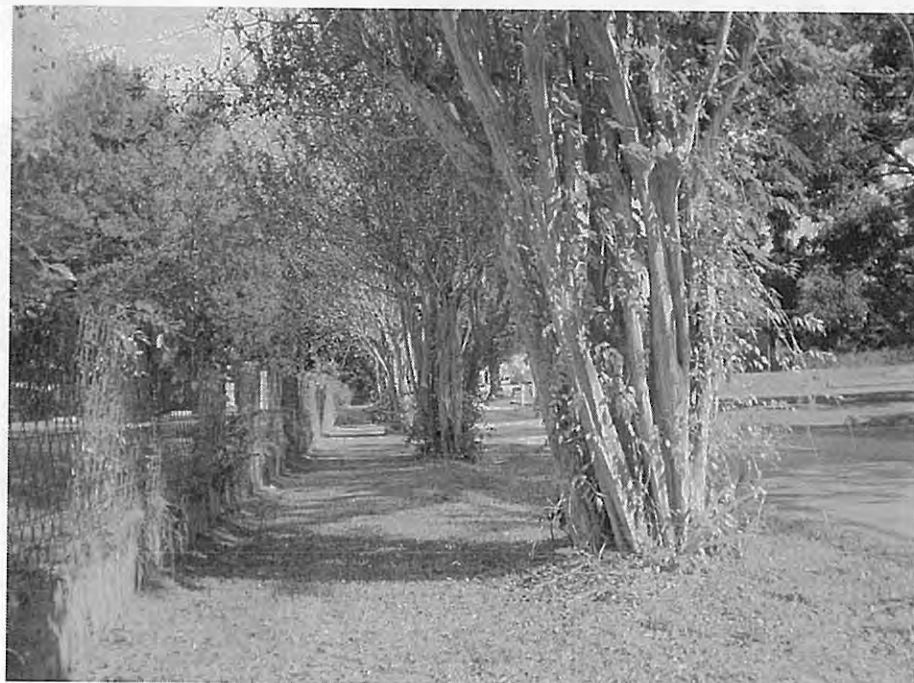
Worn grassy sidewalk

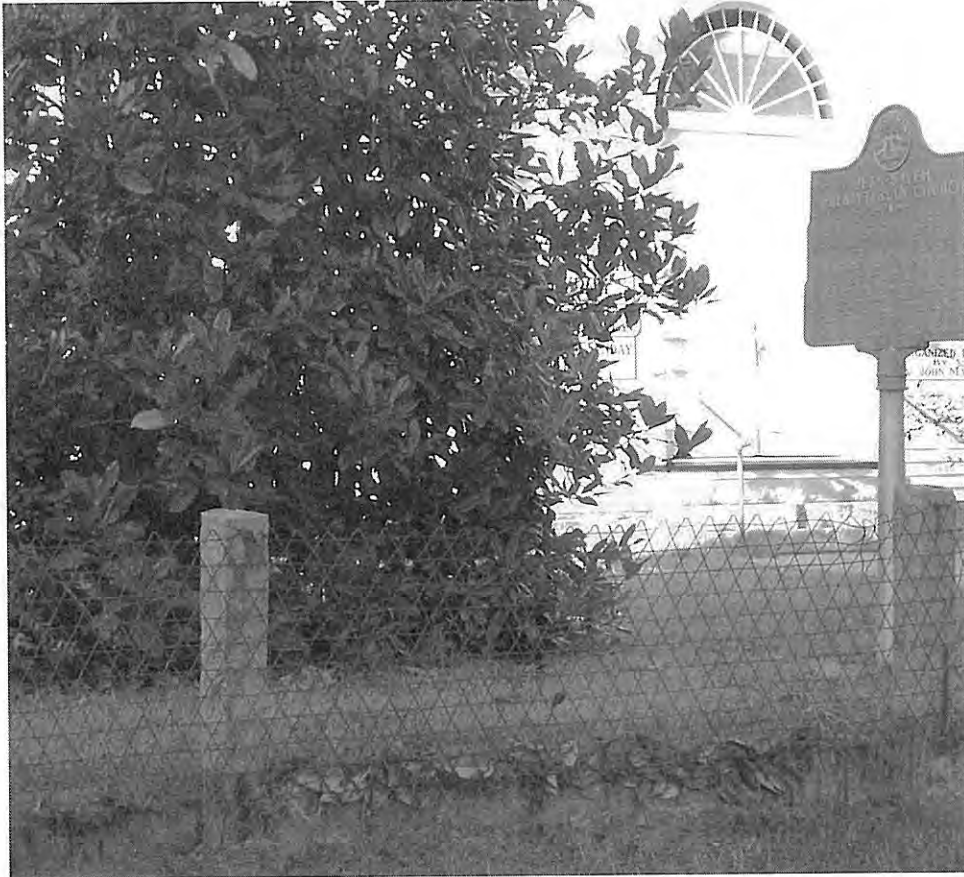
Wire fence supported by granite posts.

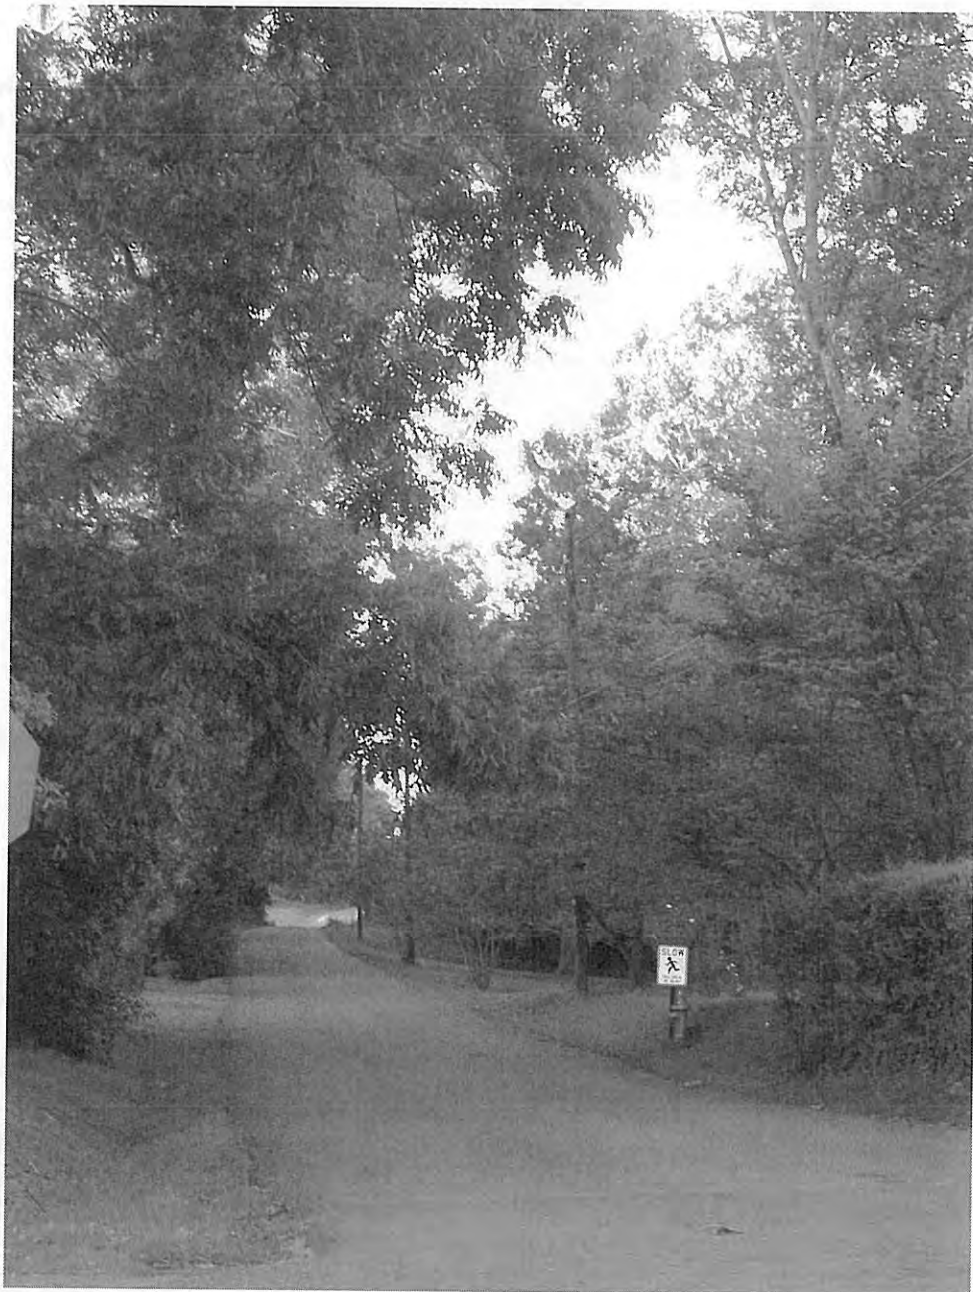
Residential streets are typically narrow and tree shaded.

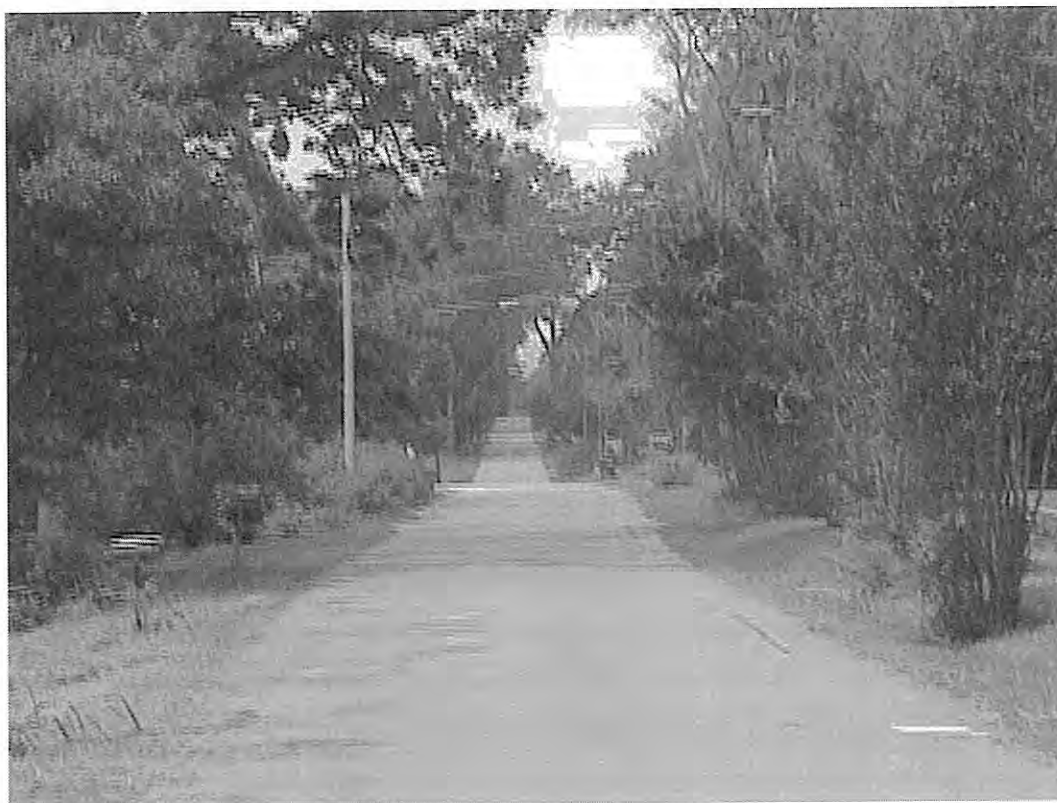
City streets are characterized by arching canopies of shade trees. The first impression of Lexington is of a green and pleasant place. This tree cover makes a very important contribution to the inviting and historic character of Lexington and should be preserved.

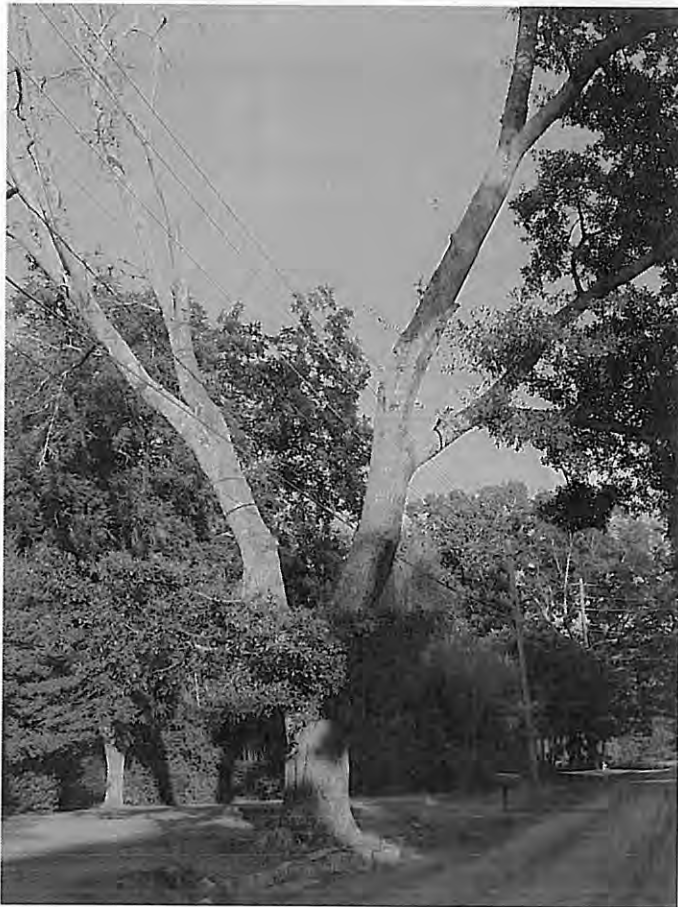
Trees damaged by excessive trimming for power lines.
